CALSPAN ON-SITE AIR BAG DEPLOYMENT INVESTIGATION
CALSPAN CASE NO. 92-22
VEHICLE - 1991 MERCURY GRAND MARQUIS LS
LOCATION - [REDACTED], AL
ACCIDENT DATE - [REDACTED], 1992

14. Sponsoring Agency Code	
15. Supplementary Notes On-site investigation of an air bag deployment crash that resulted in multiple fractures of the driver's right forearm.

16. Abstract <p>This investigation focused on an intersection crash that involved a 1991 Mercury Grand Marquis that was equipped with a driver's side air bag Supplemental Restraint System. The vehicle sustained a 10 o'clock direction of force impact and underwent a velocity change of 24 KPH (15 mph). The driver was a 73-year-old female with a height of 149.9cm (59") and weight of 56.3kg (125 lbs.). She was wearing the manual 3-point lap and shoulder belt system.</p> <p>At impact, the driver was initiating a left turn and her right hand was positioned at the 11 o'clock sector of the wheel with her forearm extending over the air bag module. As the SRS deployed, the upper air bag module cover flap and air bag impacted her right forearm resulting in AIS-3 level fractures of the radius and ulna and a 340° laceration of the forearm. In addition to t

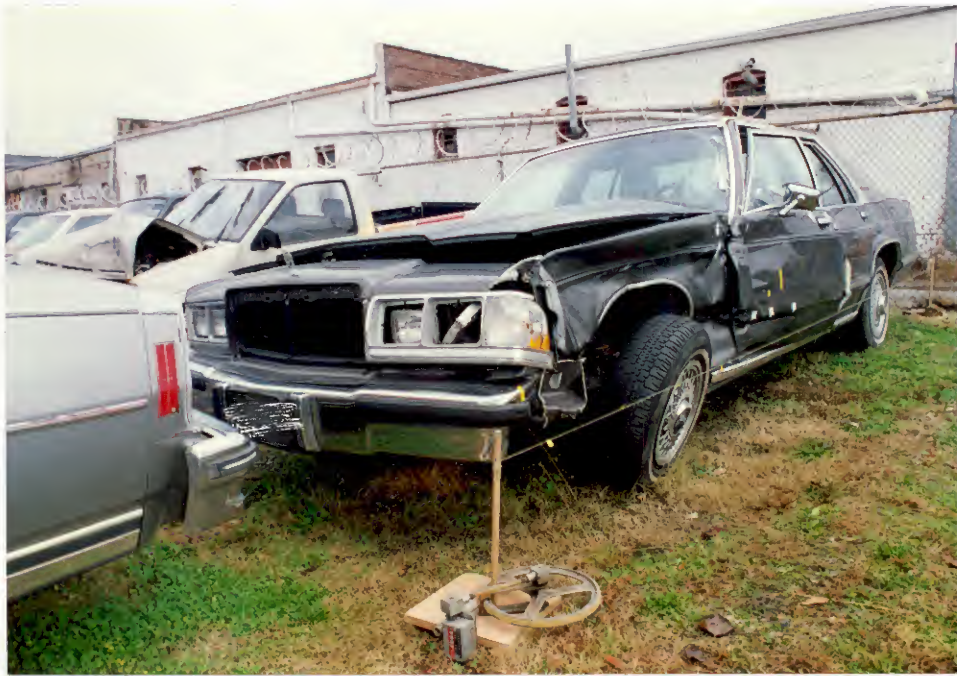
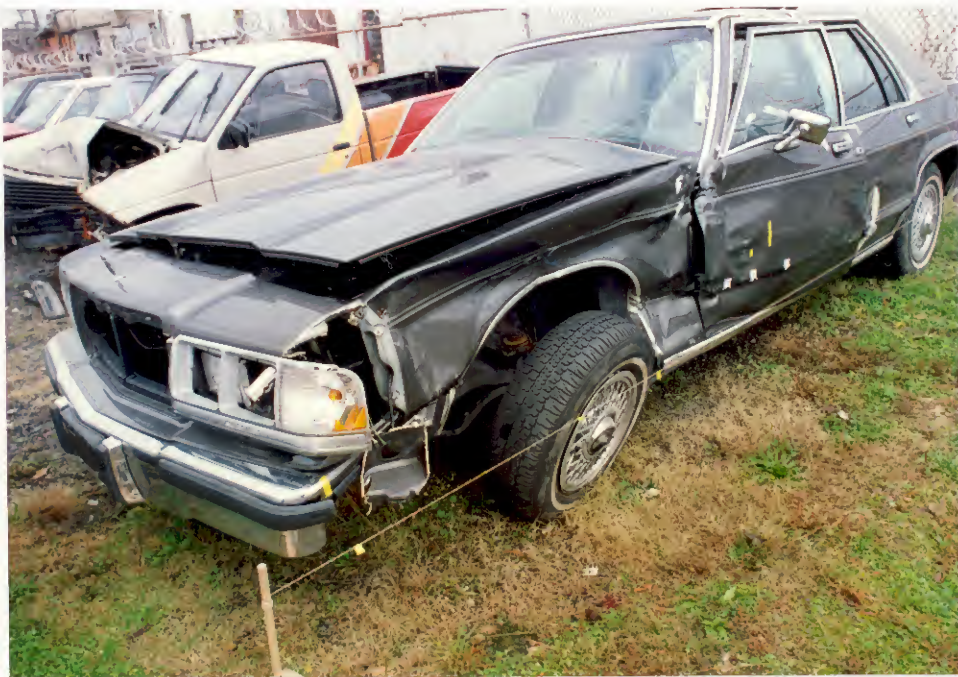
Left Front Three-Quarter Views Of The Mercury Grand Marquis.

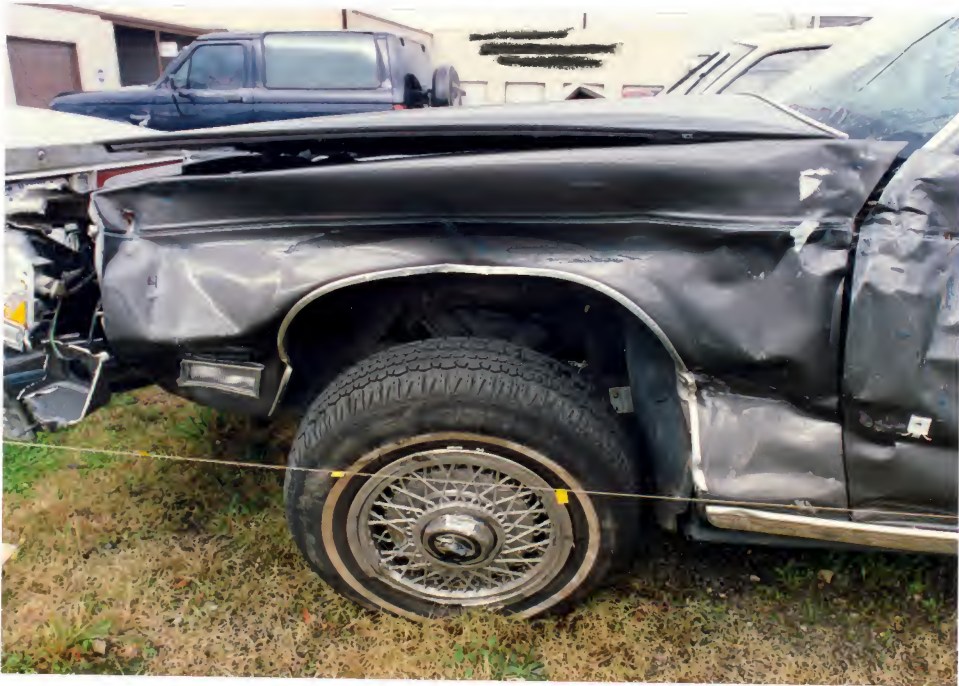
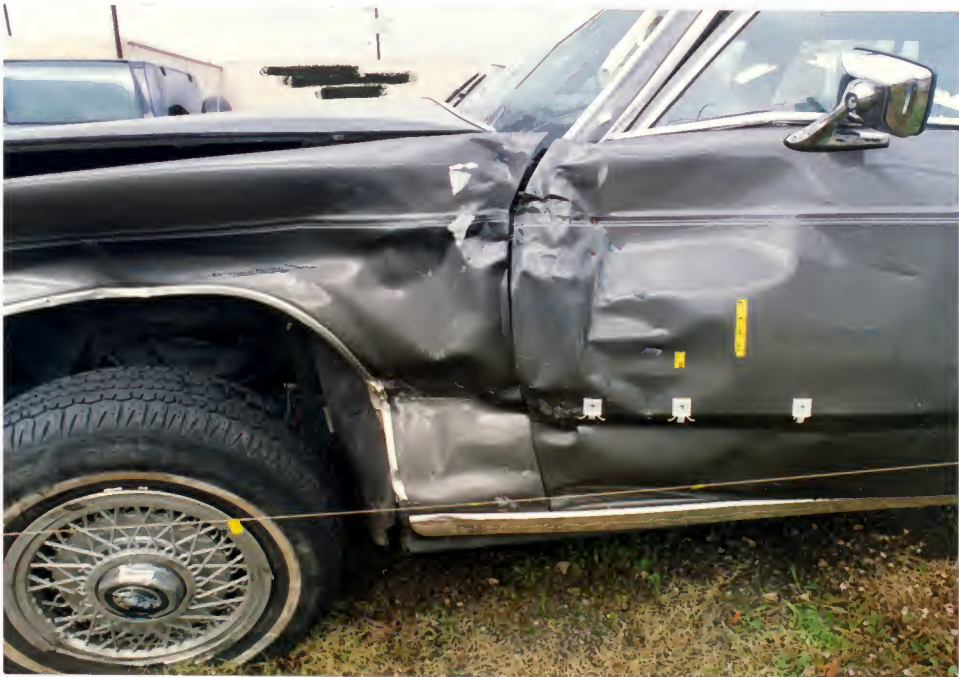
Direct Contact Damage That Resulted From The Initial Impact
Sequence With Vehicle #2.

Primary - The 1991 Mercury Grand Marquis was struck on the left front side area by the full frontal area of vehicle #2. Direct contact damage began at the corner area of the front bumper and extended 184.2cm (72.5") rearward across the left front fender, left front tire and wheel, and onto the left front door. The impact force against the left front tire and wheel fractured the upper ball joint stud at the base of the control arm. Maximum crush was 30.2cm (11.9") located on the left front wheel opening directly above the axle position. Crush values at this level were as follows: $C_1 = 6.4\text{cm}$ (2.5"), $C_2 = 20.6\text{cm}$ (8.1"), $C_3 = 24.6\text{cm}$ (9.7"), $C_4 = 27.3\text{cm}$ (10.75"), $C_5 = 22.9\text{cm}$ (9.0"), $C_6 = 3.2\text{cm}$ (1.25").

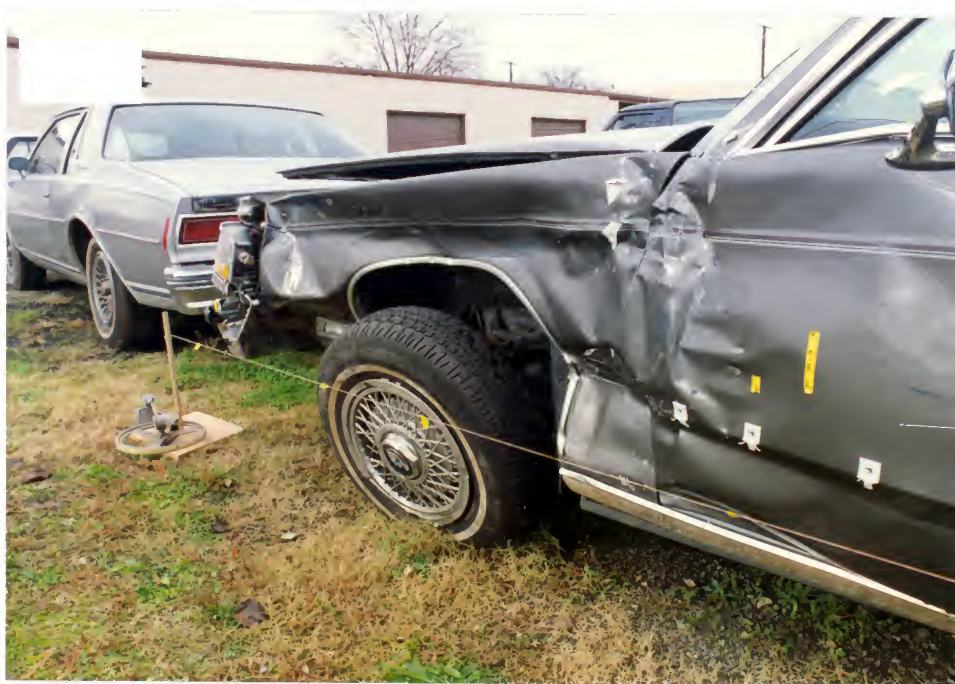
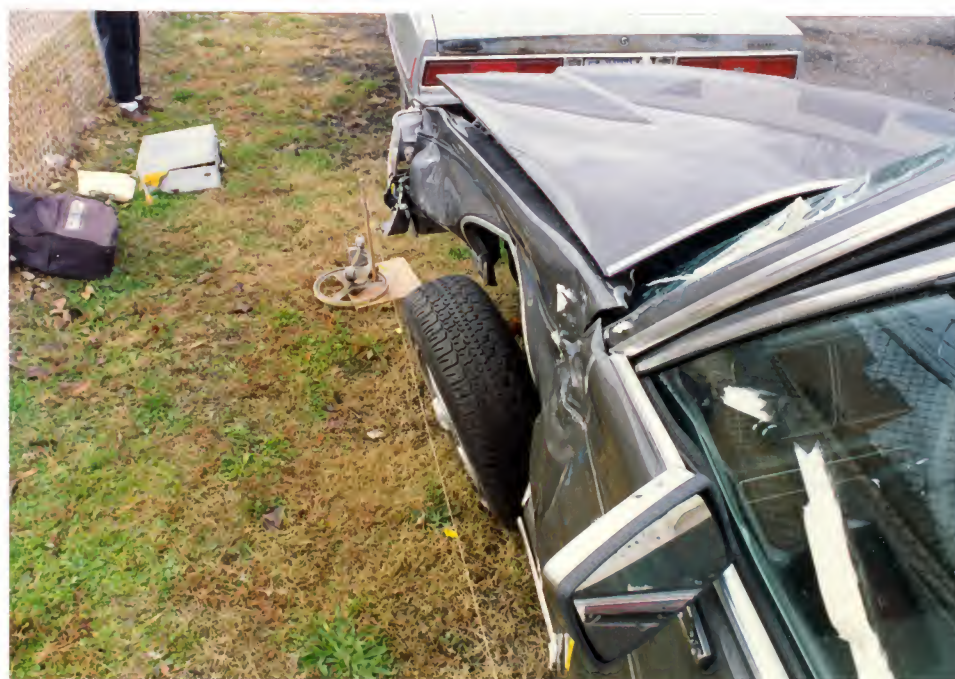
Extent Of Crush From The Primary Impact Sequence.

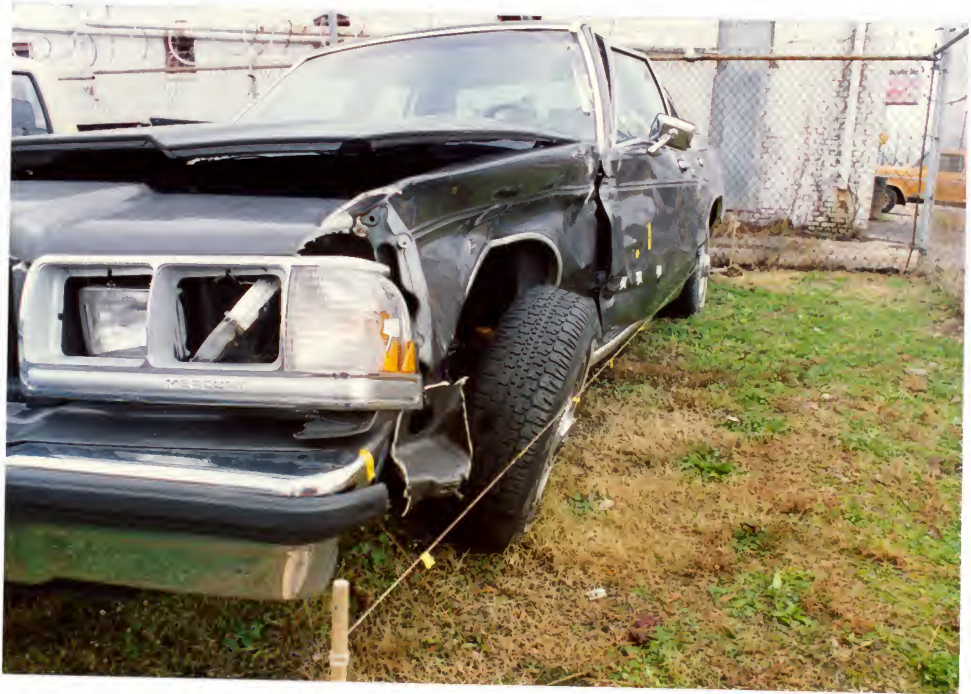
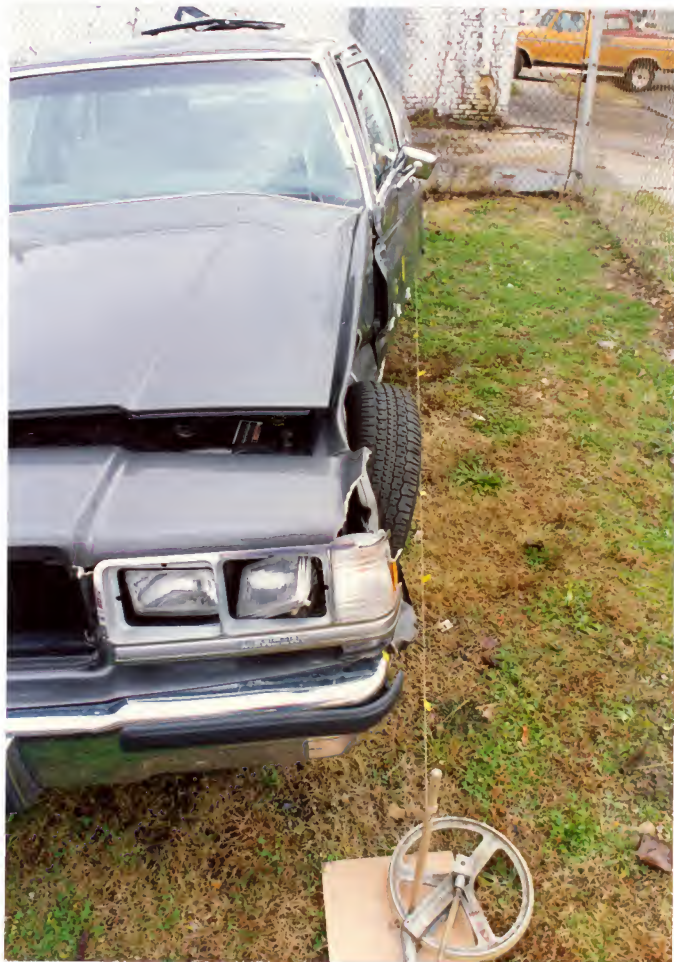
Frontal Views Showing The Extent Of Crush.

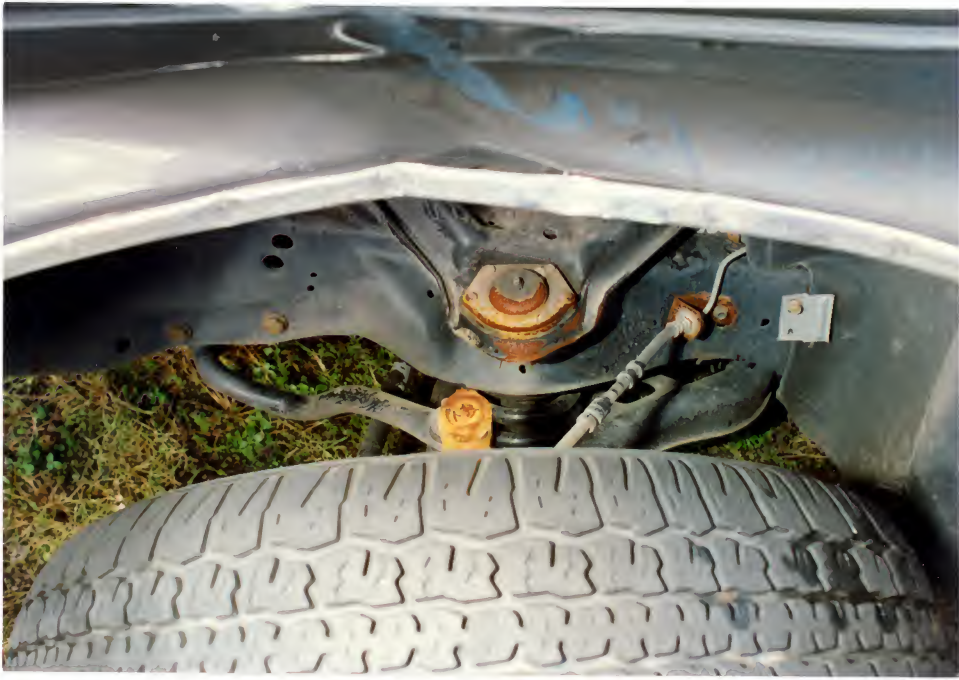
Fractured Left Upper Ball-Joint.

Damaged components included the front bumper, left headlamp and turn signal assembly, left front fender, hood, left front hub cap and ball joint, left A-pillar, and left front door. The displacement of the A-pillar cracked the vehicle's windshield and displaced the left roof side rail vertically upward from the A- to the B-pillar.

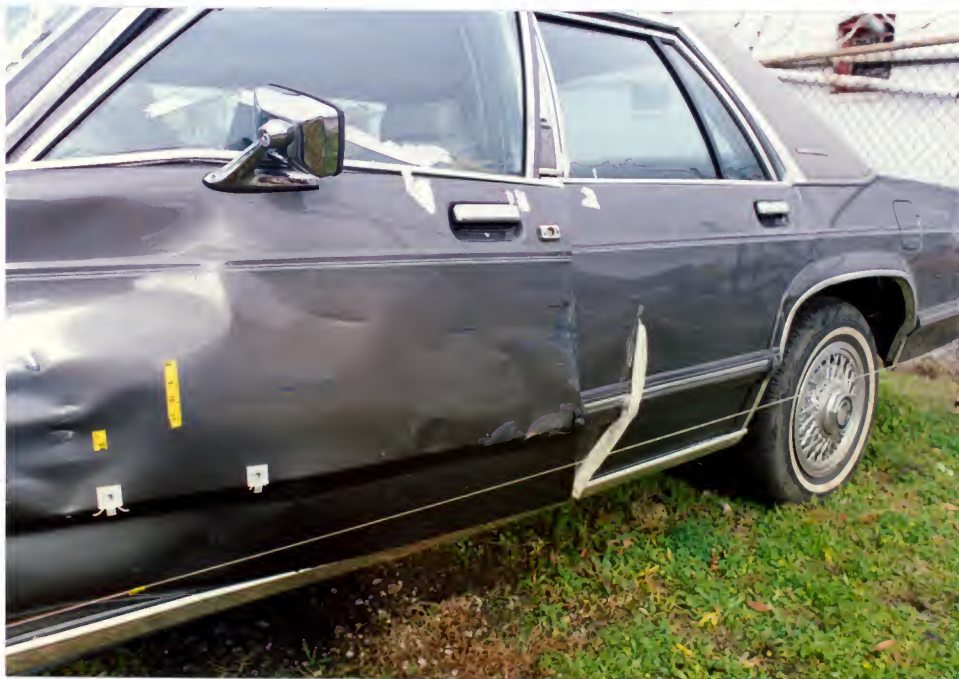
Secondary Sideslap Damage To The Left Side Of The Grand Marquis.

Secondary - The left side area of the Grand Marquis impacted the right side of vehicle #2 in a subsequent sideslap configuration. Direct contact damage began at the mid portion of the left front door, 188cm (74") forward of the left rear axle, and extended 308cm (121.25") rearward onto the left taillamp lens. The damage consisted of superficial dents and paint transfers that extended across both left doors and the quarter panel. Maximum crush was 2.5cm (1") at various points on the left front door. There was a 1.25cm (0.5") dent at the rub strip on the left rear door. The sideslap sequence damaged both left side doors, the quarter panel, and the taillamp lens. There was no induced damage from the secondary collision.

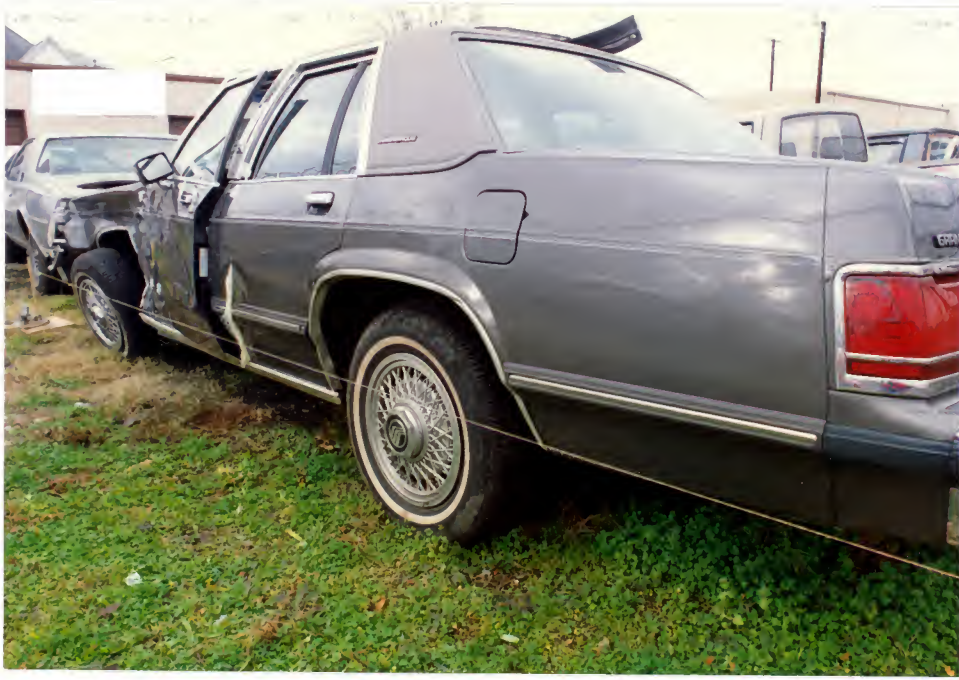
Sideslap Damage On The Quarter Panel And Taillight Lens.

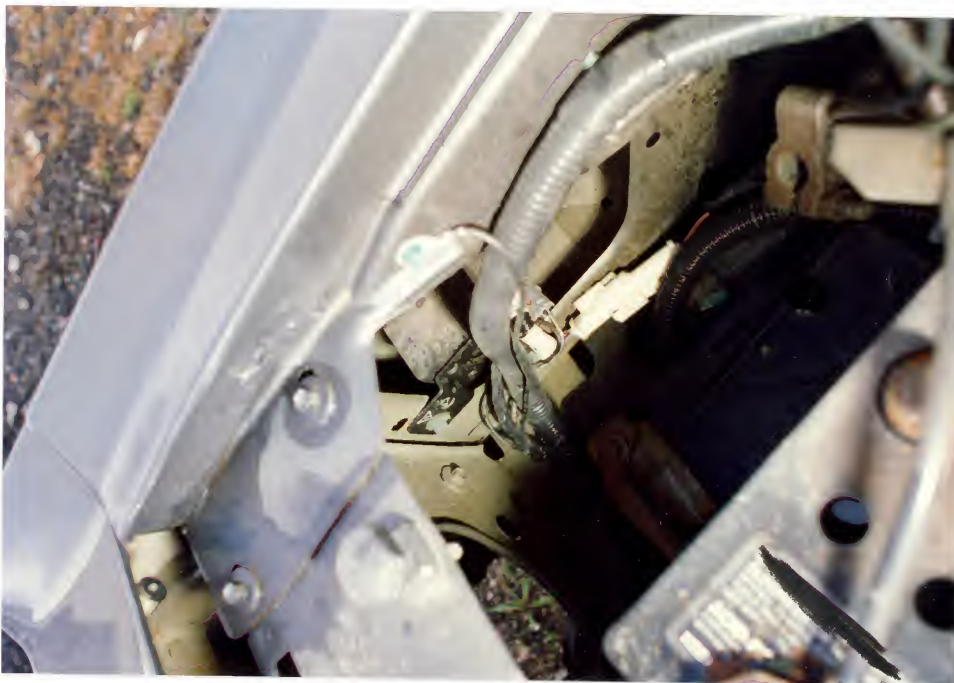
Right Front Air Bag Crash Sensor.

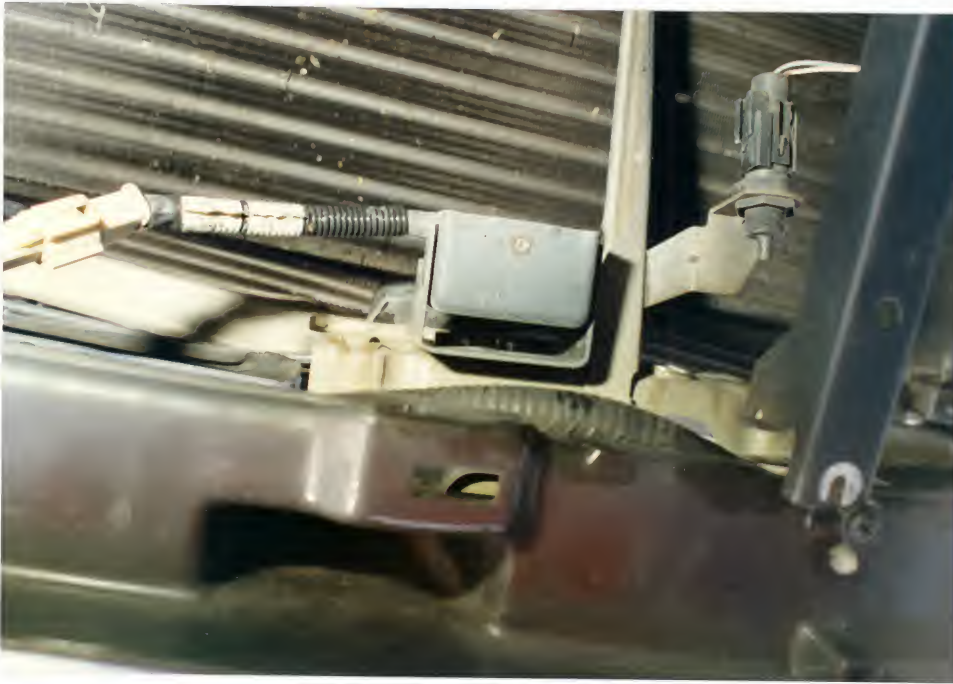
Center Front Air Bag Crash Sensor.

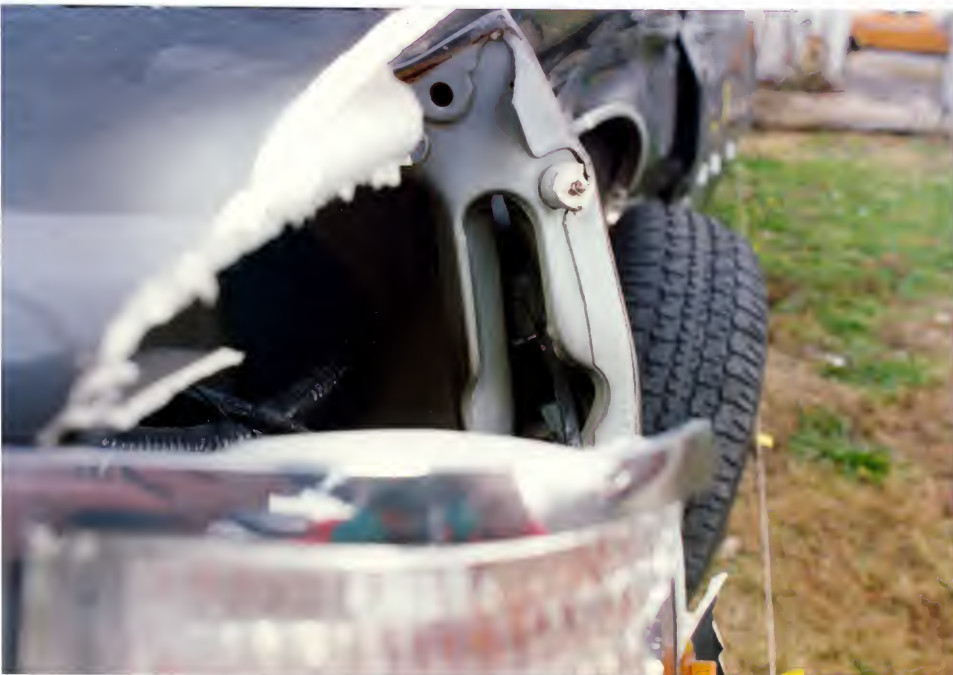
Left Front Air Bag Crash Sensor Displaced By Damage.

The 1991 Mercury Grand Marquis was equipped with a driver's side air bag Supplemental Restraint System (SRS) that deployed as a result of the front-to-side impact sequence with vehicle #2. The system consisted of three front mounted crash sensors, a safing sensor and diagnostic unit, a knee bolster, and the air bag module assembly. Two of the crash sensors were mounted to the outboard aspect of the radiator support panel, located behind the low beam headlamp assemblies. The third crash sensor was mounted to a bracket forward of the air conditioning condensor at the center of the vehicle, directly behind the grille. There was no damage to the crash sensors or associated wiring; however, the left sensor was rotated slightly in a clockwise direction due to exterior sheetmetal deformation.

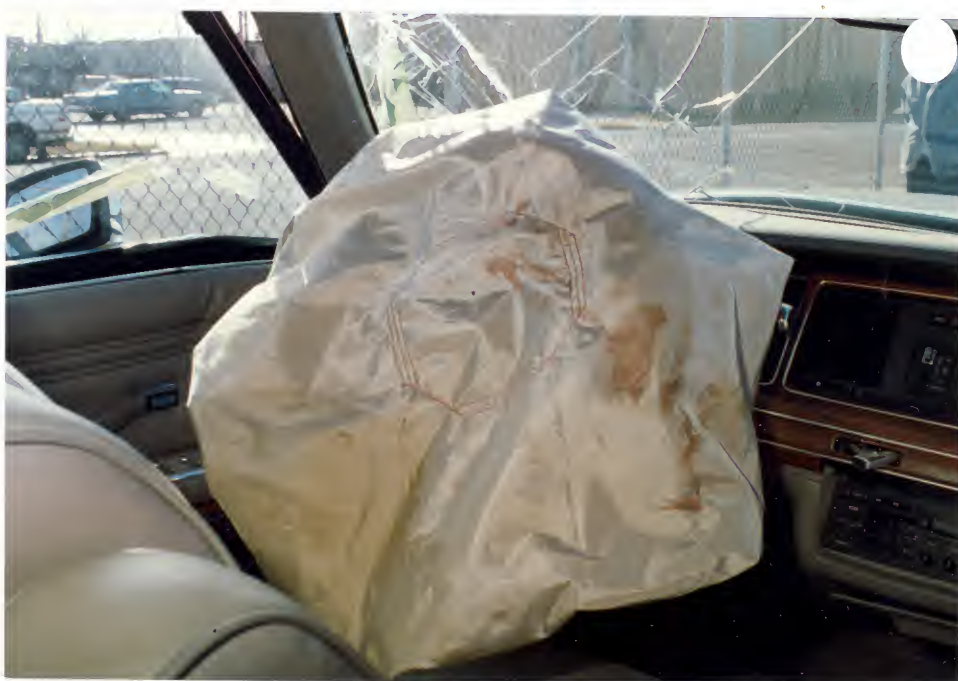
Overall View Of The Deployed Air Bag.

The air bag was constructed of a woven nylon fabric with a neoprene liner. The bag, in its deflated state, measured 61cm (24") in diameter and was tethered by four internal straps that extended from a 17.8cm (7") octagonal reinforcement that was sewn to the center of the bag. The air bag was vented by two 2.5cm (1") diameter ports located on the back side of the bag (away from driver) at the 2 and 8 o'clock positions. There was no damage or tears to the deployed air bag. The radial inflator ports of the inflation module were inspected through the bag's venting ports. There were small deposits of generant residue on the filtering screens of the ports from the 12-6 o'clock positions, extending in a clockwise direction.

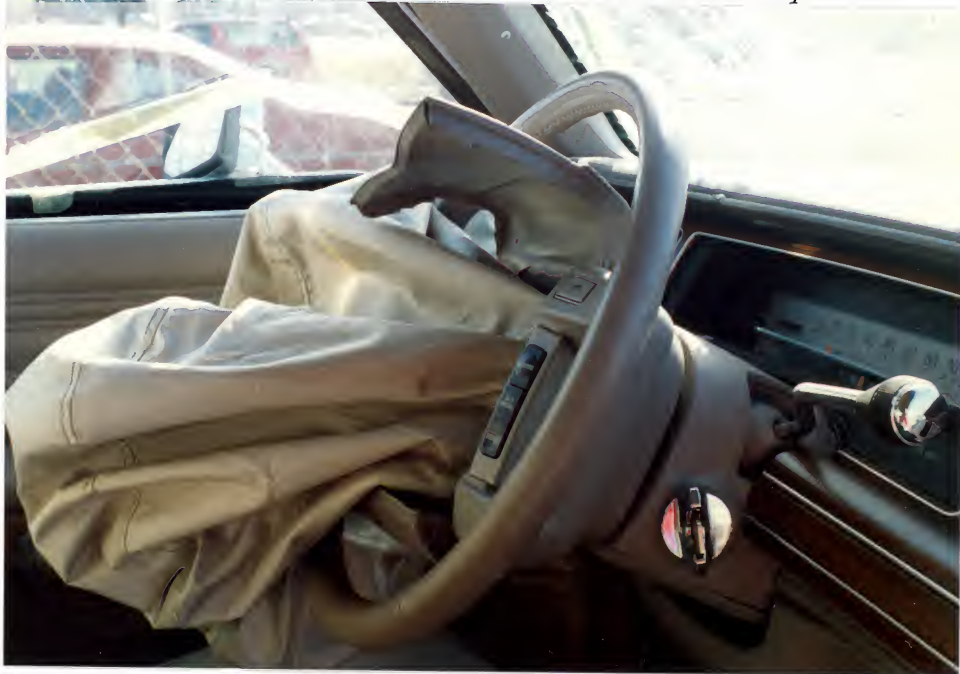
Deployed Air Bag And Module Cover Flaps.

The air bag and module cover flaps were not damaged and appeared to have deployed in a normal sequence. There was generant residue on the filtering screens of the radial ports of the inflator assembly from the 12-6 o'clock positions, extending in a clockwise direction.

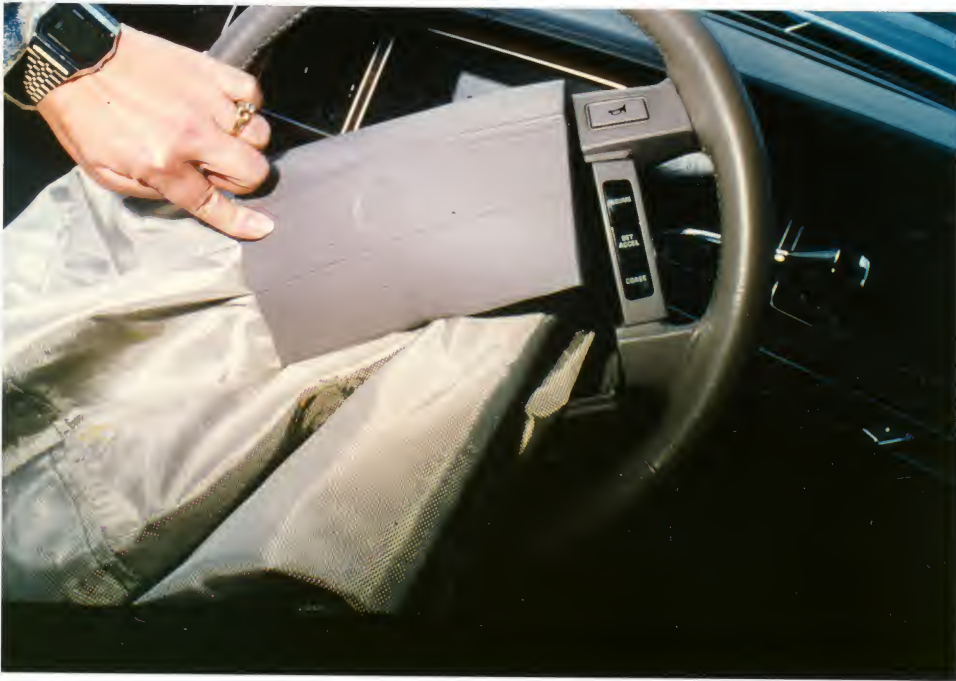
Upper Air Bag Module Cover Flap.

At impact, the driver's air bag system deployed. The upper module flap contacted the anterior and lateral aspect of her mid right forearm. There was no visible contact evidence (i.e., tissue transfers) on the upper flap. The deploying air bag subsequently contacted the same area of the forearm. As a result of air bag and module flap contact, the driver sustained multiple segmental open fractures of the right radius and ulna, with fractures of both the distal and proximal ulna (AIS-3) and a circumferential degloving laceration involving the skin and subcutaneous tissue down to the muscle layer which involved approximately 340° of the forearm. The contact sequence also fractured the right olecranon (AIS-2). The driver sustained a fracture of the proximal phalanx of the right fifth digit from probable contact with the expanding air bag.

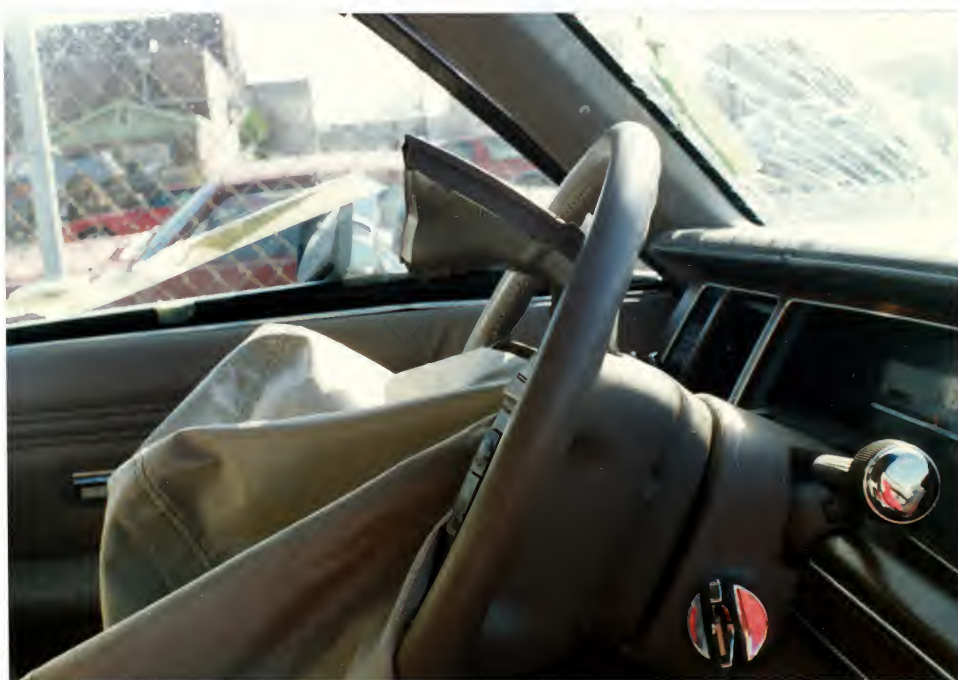
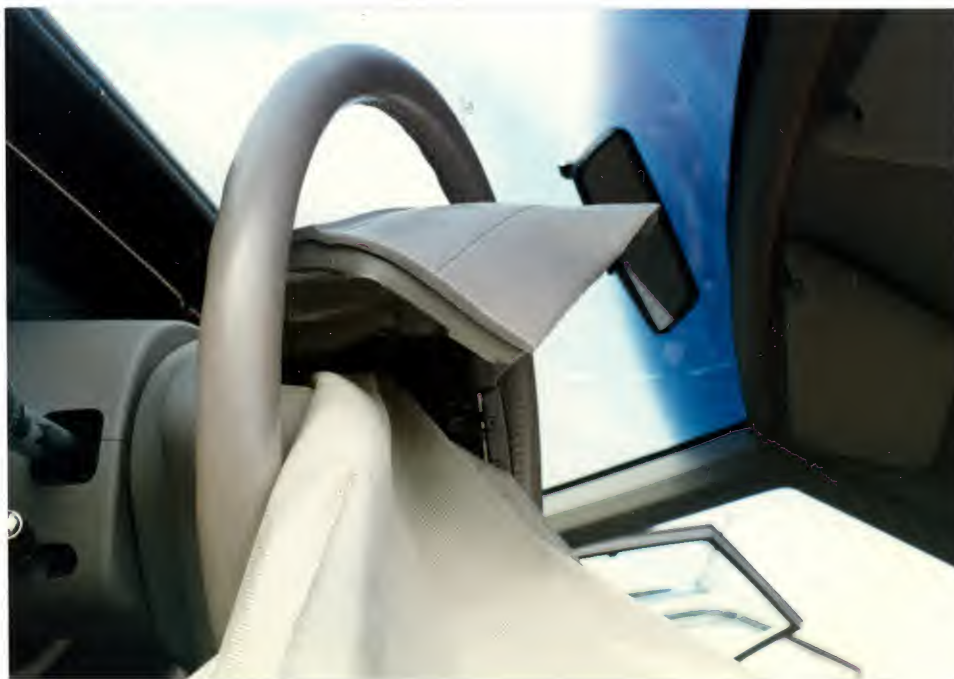
Perpendicular Views Of The Upper Air Bag Module Cover Flap.

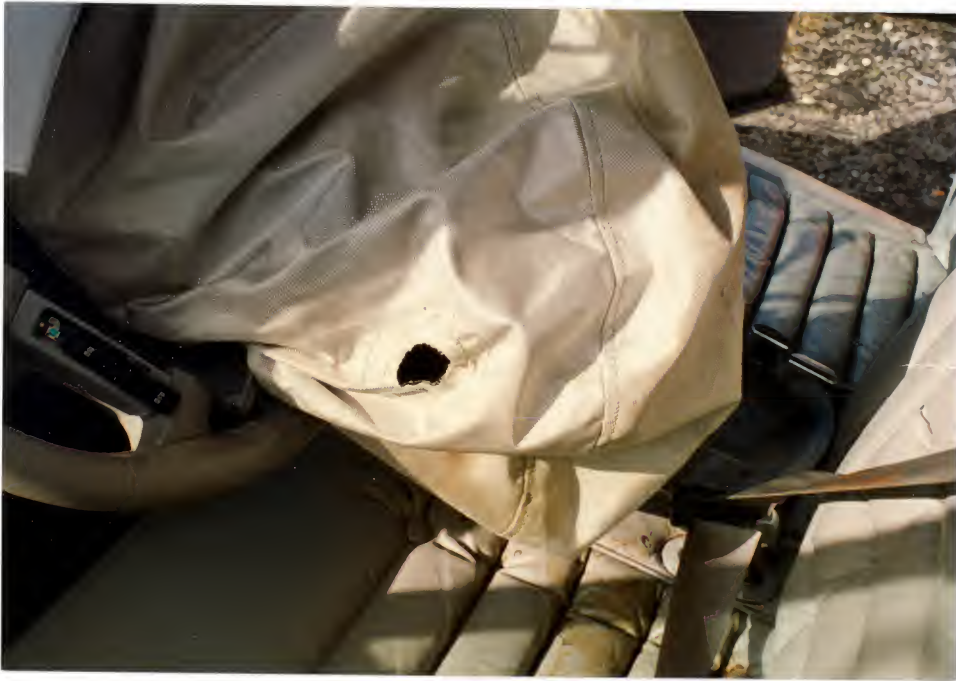
Venting Port At The 8 O'Clock Position.

The air bag was typical in construction and was vented by two 2.5cm (1") ports located on the back side of the bag (away from the driver) at the 2 and 8 o'clock positions. The bag was tethered by four internal tether straps and a 17.8cm (7") octagonal reinforcement sewn to the center of the bag. There were large blood stains at the lower left and right quadrants of the bag. Examination of the bag with a 8X magnifying lens yielded tissue transfers located at the lower right quadrant of the bag. Small tissue deposits were noted 16.5cm (6.5") right of the bag's centerline and 3.8cm (1.5") below the horizontal centerline and 15.2cm (6") right and 18.4cm (7.25") below the referenced horizontal line.

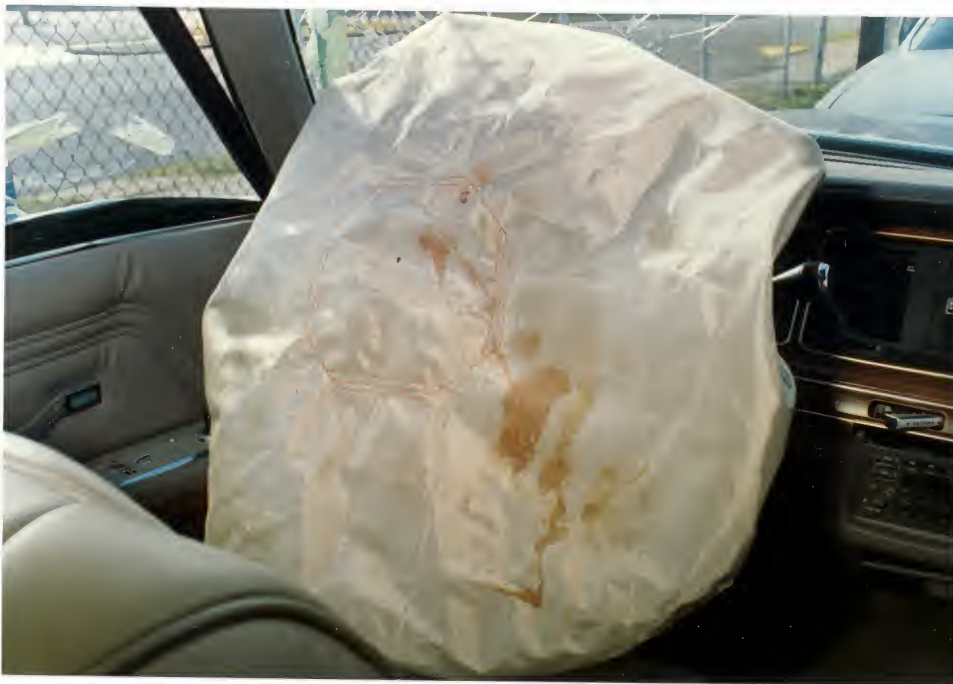
Close-Up View Of The Driver's Air Bag.

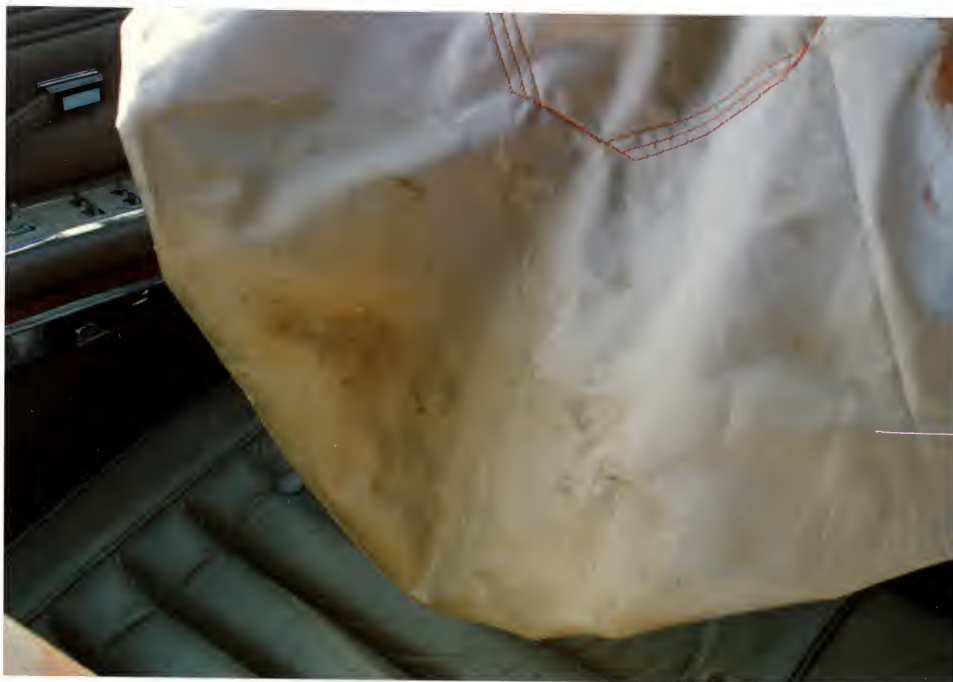
Water And Blood Stain At the Lower Left Quadrant Of The Air Bag.

The face of the air bag had two large blood stains at the lower left and lower right quadrants. The stain at the lower left quadrant of the bag was faint in color and appeared to have been saturated by rain water. The stain on the right side of the bag began at the upper right corner of the tether reinforcement and continued to the lower right portion of the bag. The bag was examined with an 8X magnifying lens which revealed small tissue transfers at the lower right quadrant of the bag. The tissue fragments were located 16.5cm (6.5") right of center and 3.8cm (1.5") below the horizontal centerline and 15.2cm (6") right and 18.4cm (7.25") below the referenced centerline.

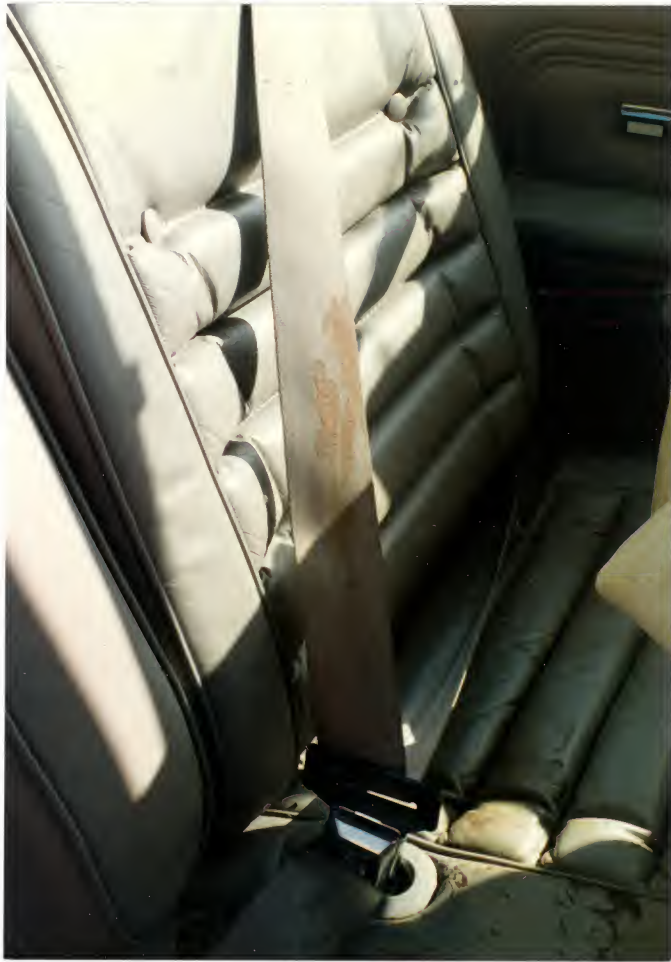
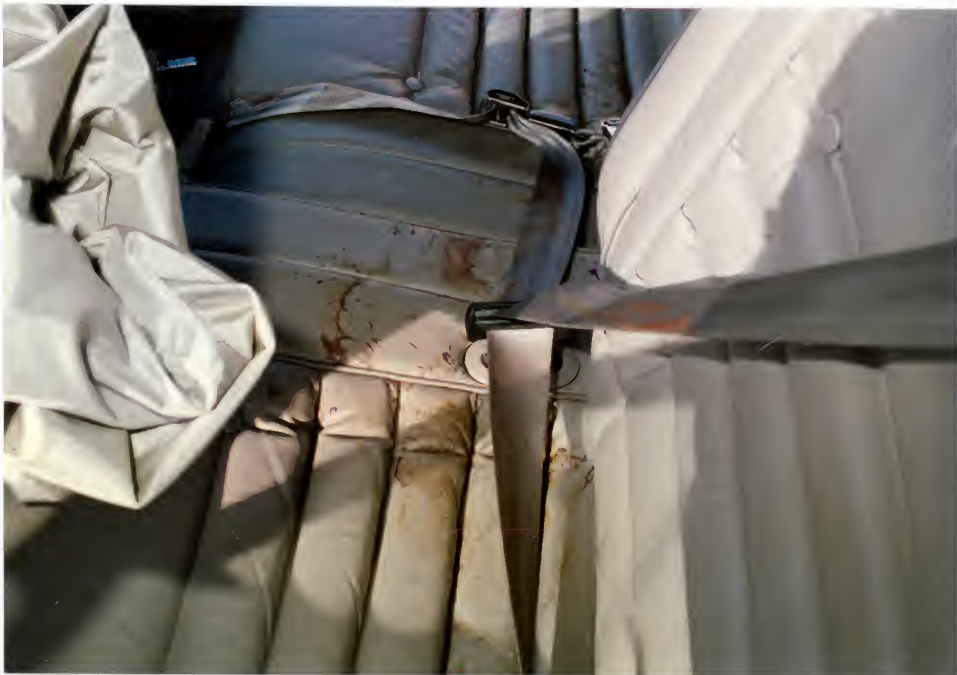
Blood On The Driver's Belt Webbing At The Latchplate Area.

The driver was wearing the manual 3-point lap and shoulder belt system. Although no loading evidence was visible on the belt webbing, blood stains were noted to the shoulder belt webbing in the area of the latchplate. Faint blood and tissue deposits were also visible on the webbing at the D-ring area.

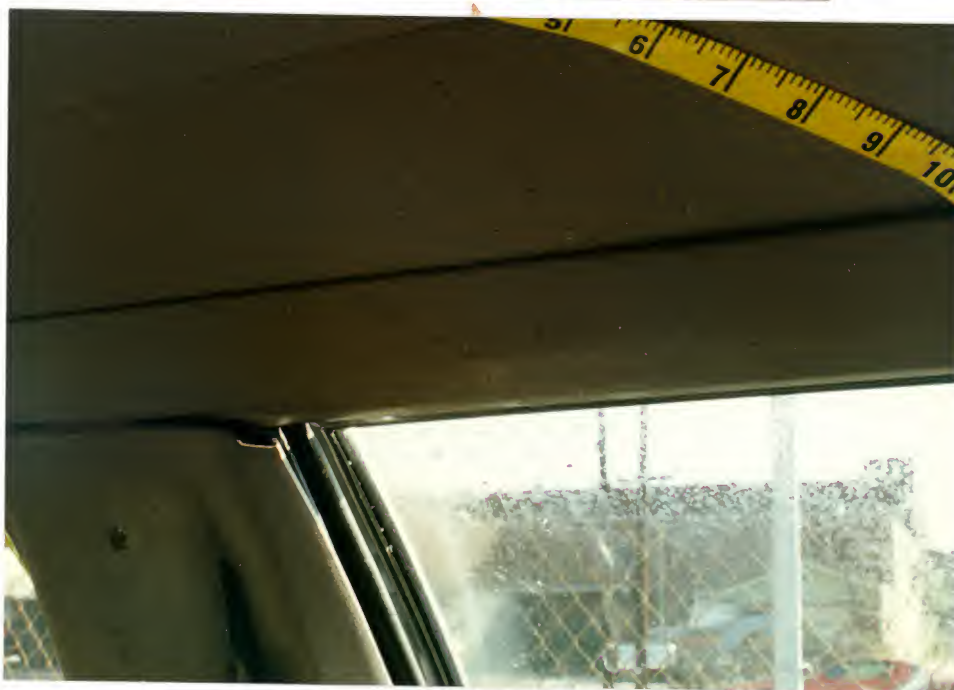
Body Fluid And Tissue Spatter On Left Headliner,
Siderail, And B-Pillar.

The expanding air bag displaced the driver's right arm up and over her head in a circular pattern. Tissue and blood spatters were noted to the headliner, left B-pillar and siderail areas, and across the full width of the rear seatback. The driver, who is a retired nurse, remained conscious and coherent throughout the event and stated during the Calspan interview that her arm "looked like a piece of frayed sausage." She slid to the center seated position and waited for rescue personnel to arrive on-scene.

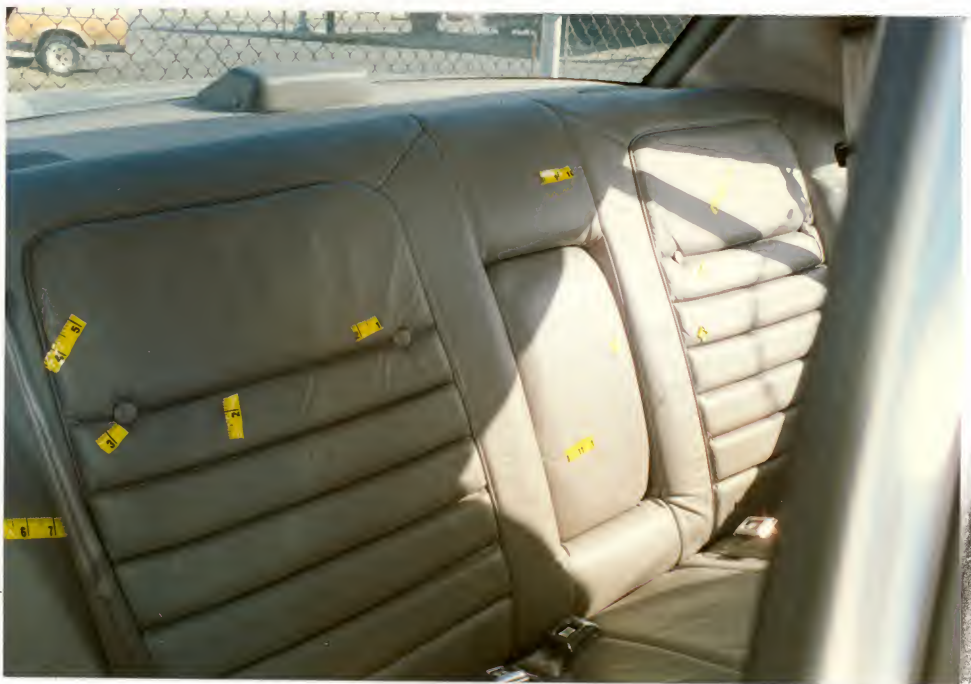
Tissue Spatter Across Rear Seat Back.

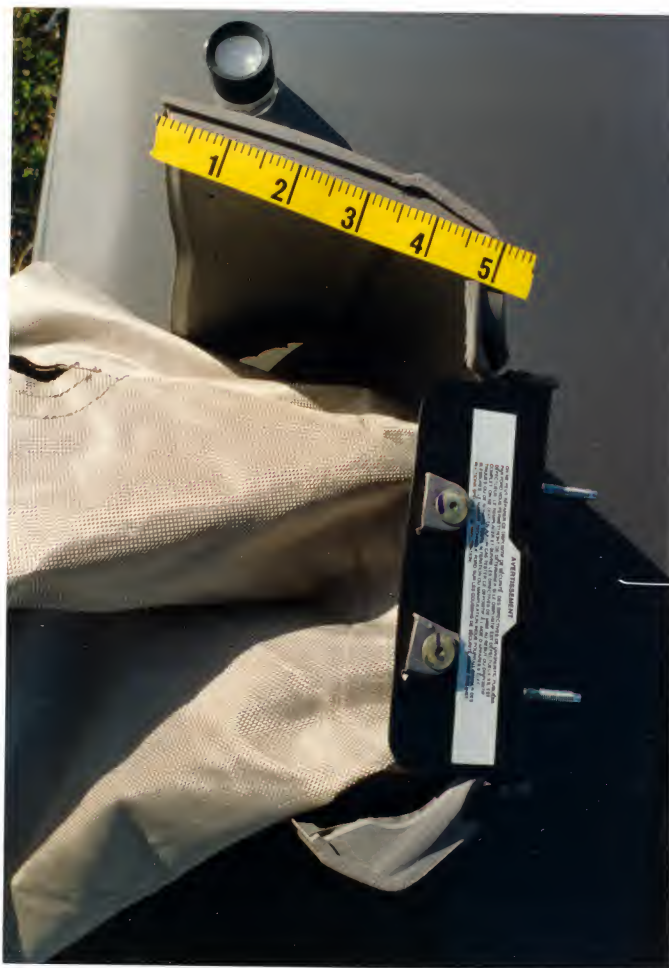
Right Side View Of The Air Bag Module Cover Flaps.

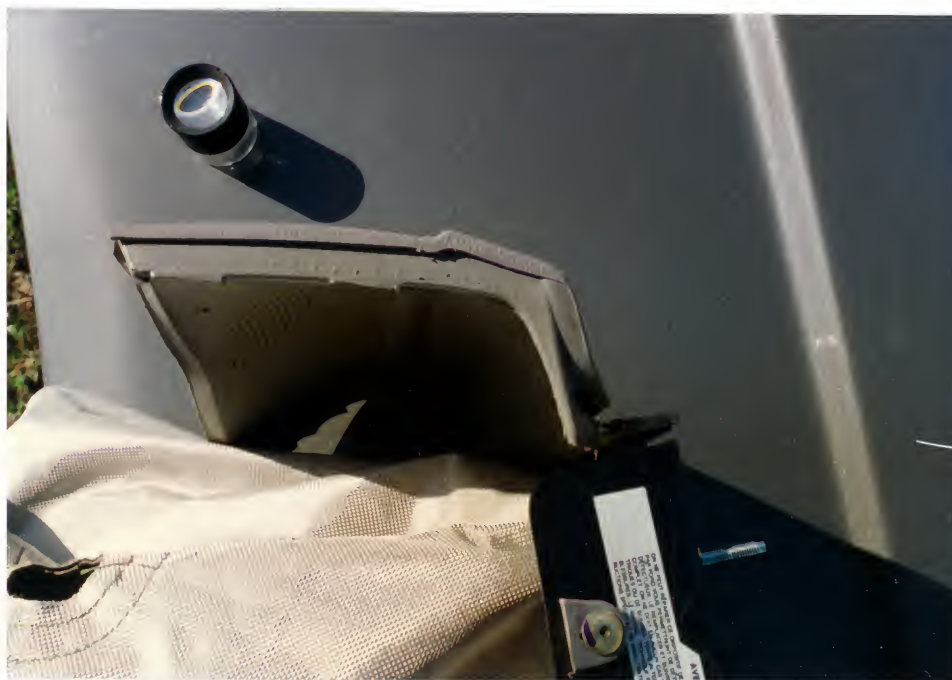
Close-up View Of The Upper Flap.

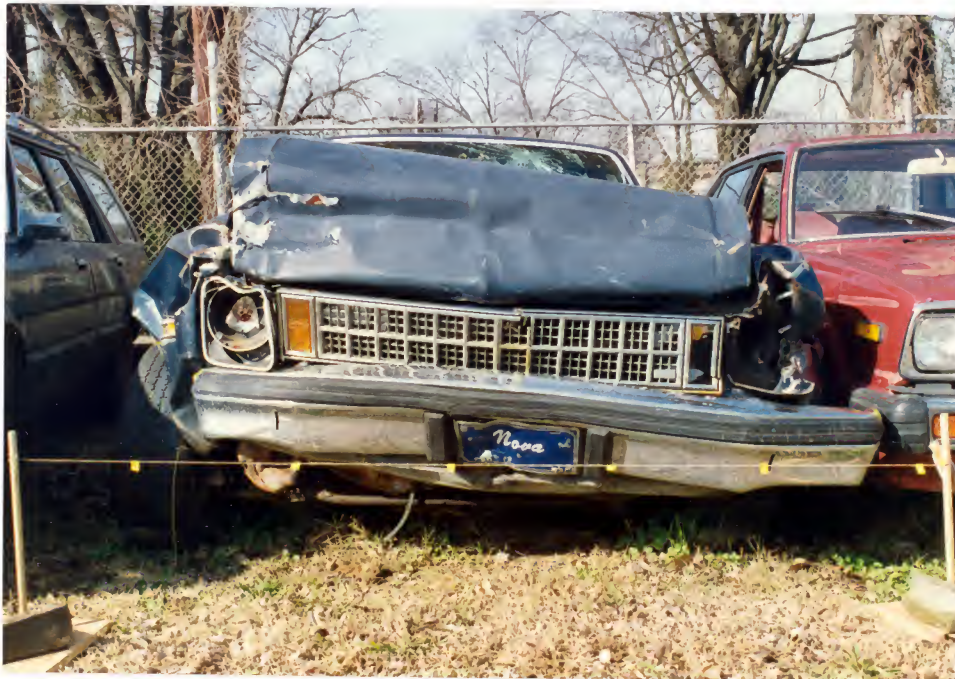
Frontal View Of Vehicle #2.

Primary - The 1977 Chevrolet Nova sustained moderate frontal damage from its impact sequence with the left side of the Grand Marquis. Maximum crush was 36.8cm (14.5") located at the right corner of the front bumper. Direct contact damage was 170.2cm (67") in length and was distributed across the full frontal width of the vehicle. Crush values at bumper level were as follows: $C_1 = 7.6\text{cm}$ (3"), $C_2 = 8.9\text{cm}$ (3.5"), $C_3 = 15.9\text{cm}$ (6.25"), $C_4 = 22.9\text{cm}$ (9.0"), $C_5 = 27.9\text{cm}$ (11.0"), $C_6 = 36.8\text{cm}$ (14.5").

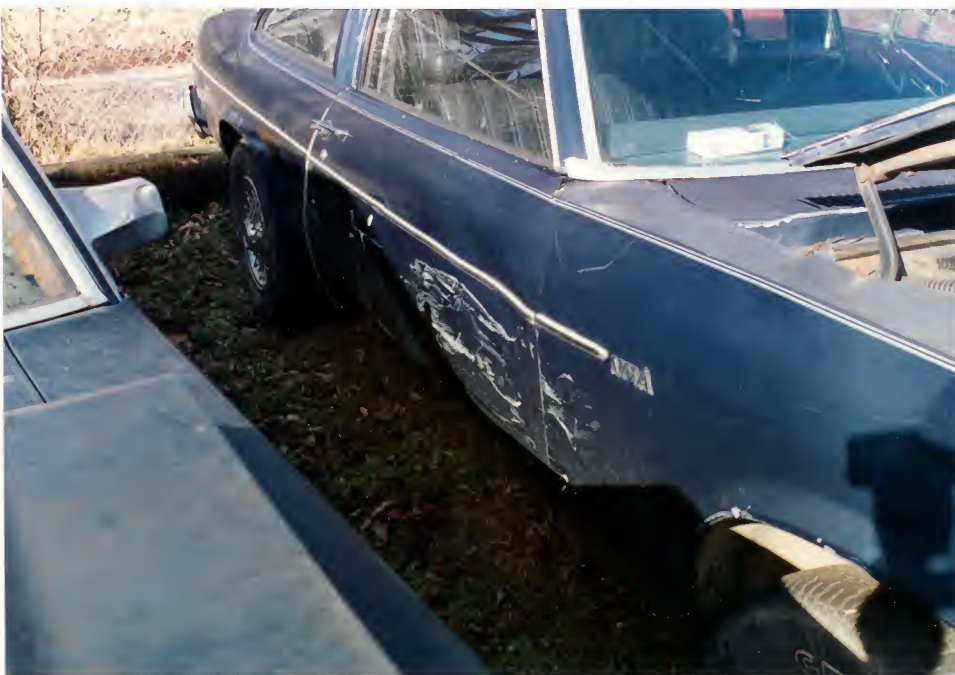
Sideslap Damage To The Right Side Of Vehicle #2.

Secondary - Following the initial impact, the Chevrolet Nova engaged in a subsequent sideslap collision with the left side of the Grand Marquis. The sideslap produced minor damage to the right side of the Nova, beginning on the right fender 20.3cm (8") forward of the front axle. The damage, which consisted of superficial body deformation and paint transfers, extended 291.5cm (114.75") rearward onto the rear quarter panel, ending 10.2cm (4") forward of the rear axle. Maximum crush was 1.3cm (0.5") located at the leading edge of the right front door. Damaged components were limited to the fender, door, and quarter panel.
